LAKE LEHIGH DAM

(NDI ID ^{Number} PA-00151
DER ID ^{Number} 64-51)

PHASE I INSPECTION REPORT.
NATIONAL DAM INSPECTION PROGRAM

GANNETT FLEMING CORDDRY AND CARPENTER, INC.
Consulting Engineers
P.O. Box 1963
Harrisburg, Pennsylvania 17105

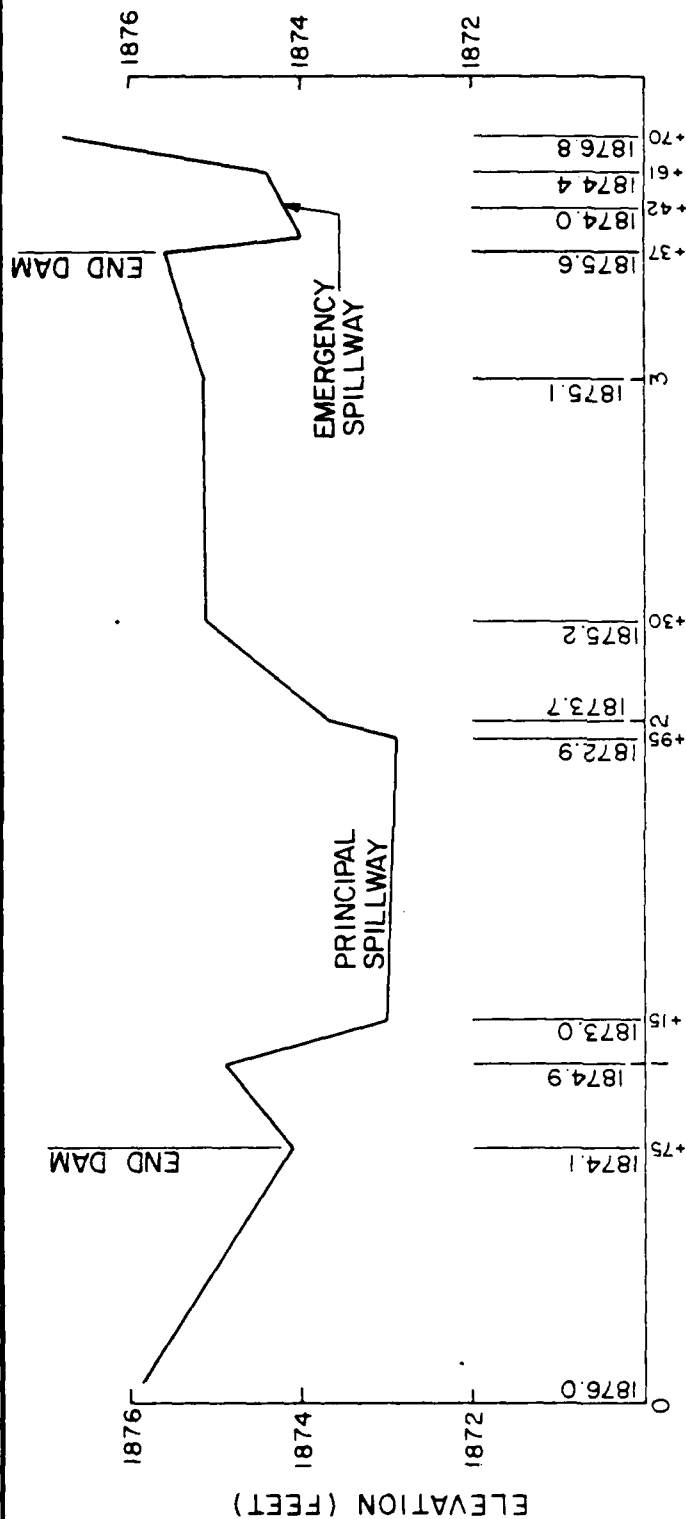
TOP OF DAM - PROFILE

b. Embankment. The crest, upstream slope, and downstream toe of the dam are partially overgrown with brush and small trees ranging in size up to six inches in diameter. Low areas were observed on the crest of the dam adjacent to and at both ends of the principal spillway. Each low area is approximately 80 to 100 square feet in size and 12 to 18 inches lower than the remainder of the embankment. Concentrated seepage was observed at the toe of the dam at both locations. A slight drawdown of the water surface was observed at the upstream side of the dam to the right of the spillway where the seepage entered the embankment. The flow could be heard rushing through the embankment at both ends of the spillway. It is possible that this seepage is causing internal erosion of the dam which could be responsible for the low areas. The low areas may also have been caused by overtopping of the dam during high pool levels. The total seepage from the dam was estimated at 500 gallons per minute (gpm). A significant portion of this is probably flowing through or under the principal spillway. The toe of the spillway could not be observed as it was submerged.
